Detention Pond 1 Improvements
VOCHOA 2014

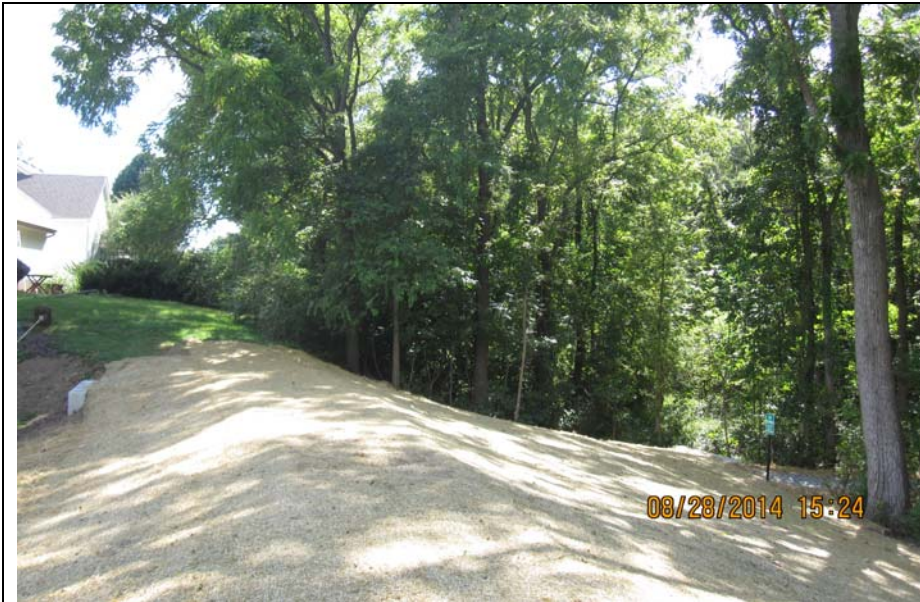
Photo #5: Finished grading of dam's crest and outslope. Removed the tree stumps, debris, wire fencing, etc. Added clean soil fill.

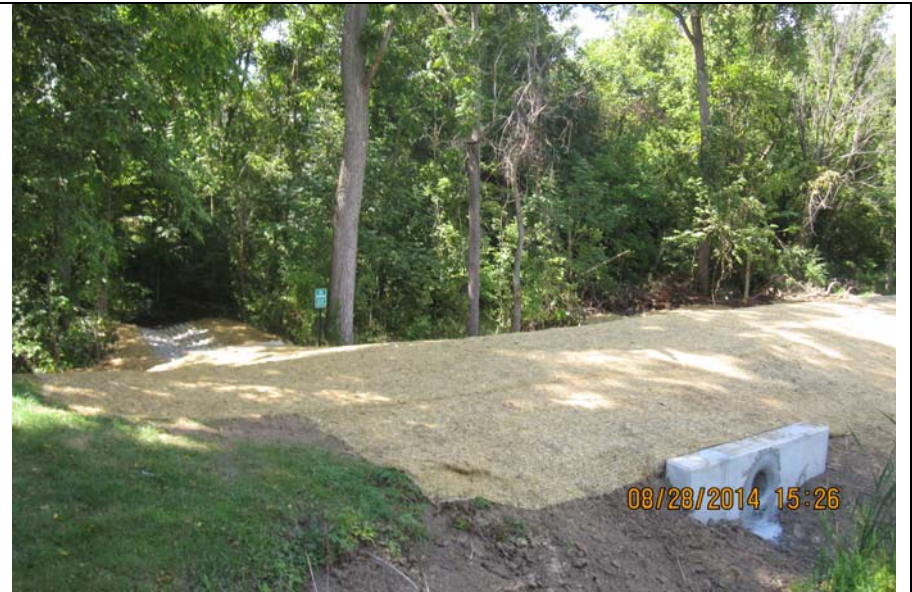
Photo #6: Installed new concrete culvert and headwalls.

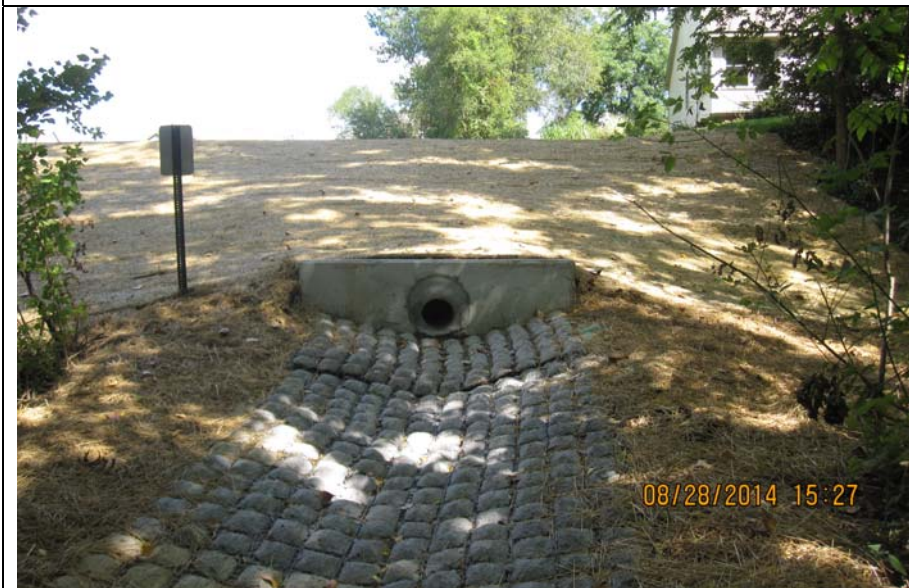
Photo #7: Installed new ditch below outlet culvert. Placed flex-a-mat material across the ditch from pipe to the stream channel.

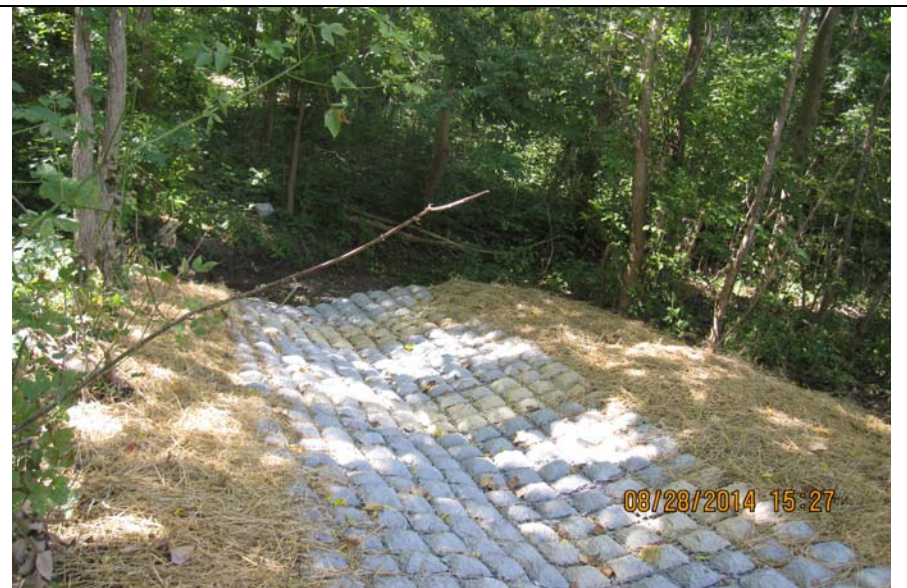
Photo #8: Installed new ditch below outlet culvert. Placed flex-a-mat material across the ditch from pipe to the stream channel.
